October 6, 1994

Re: Clark Oil Refinery  
Blue Island, Cook County, Illinois  
TDD: T05-9410-119  
PAN: EIL0844BBA

FIELD PHOTOGRAPHY LOG SHEET

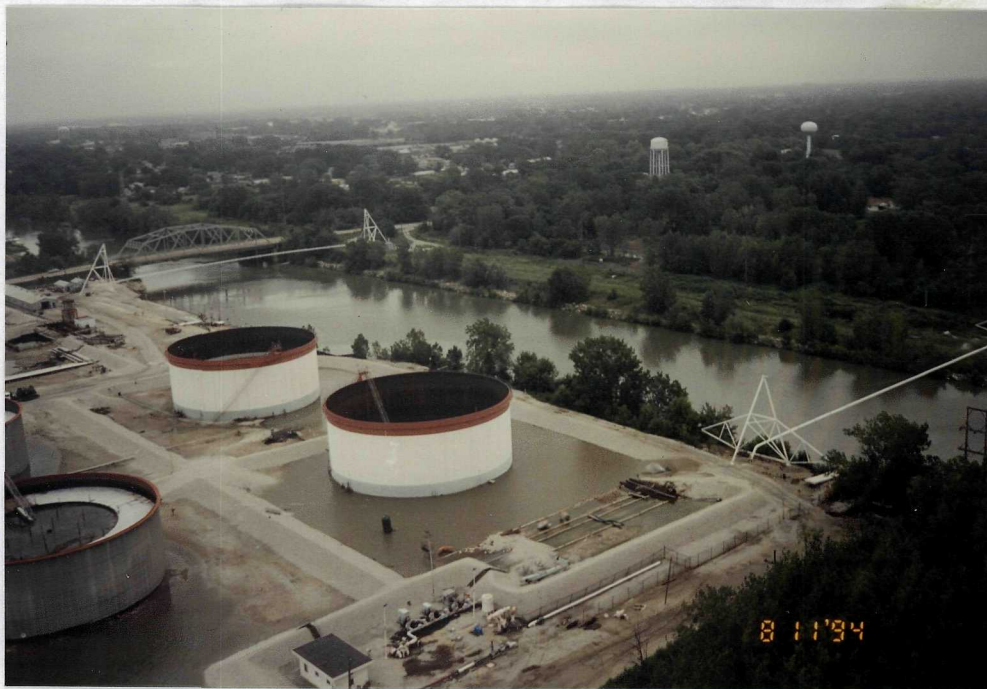
DESCRIPTION: Close-up of Clark Oil Refinery's property boundary  
which is directly adjacent to the Calumet-Sag Channel.

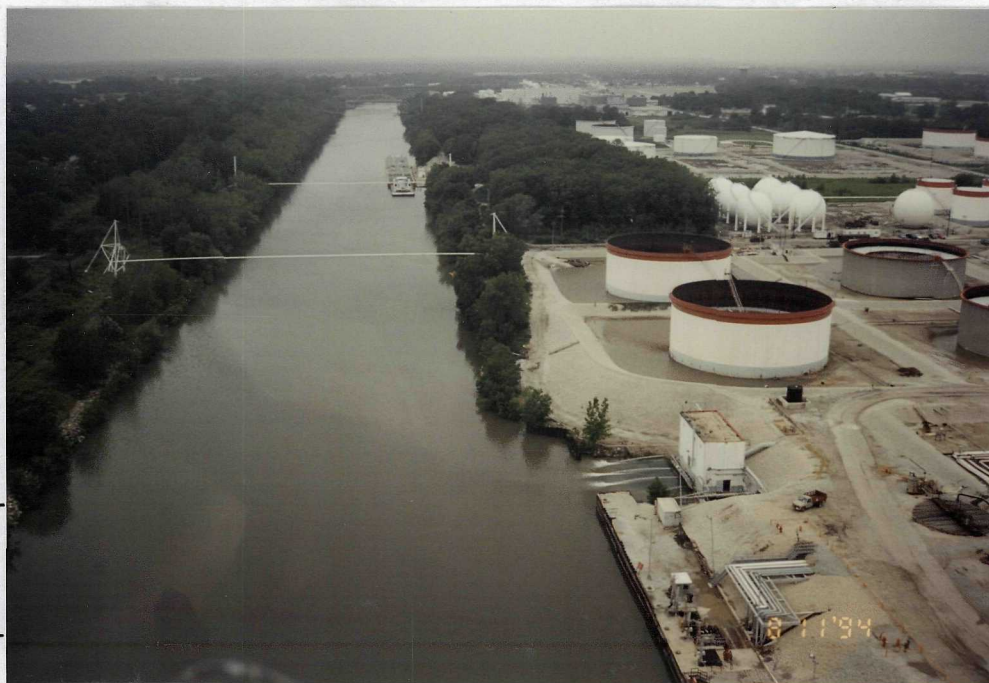
DESCRIPTION: An oil sheen was observed on the Calumet-Sag Channel.  
Oil appeared to be emanating from the Clark outfall.

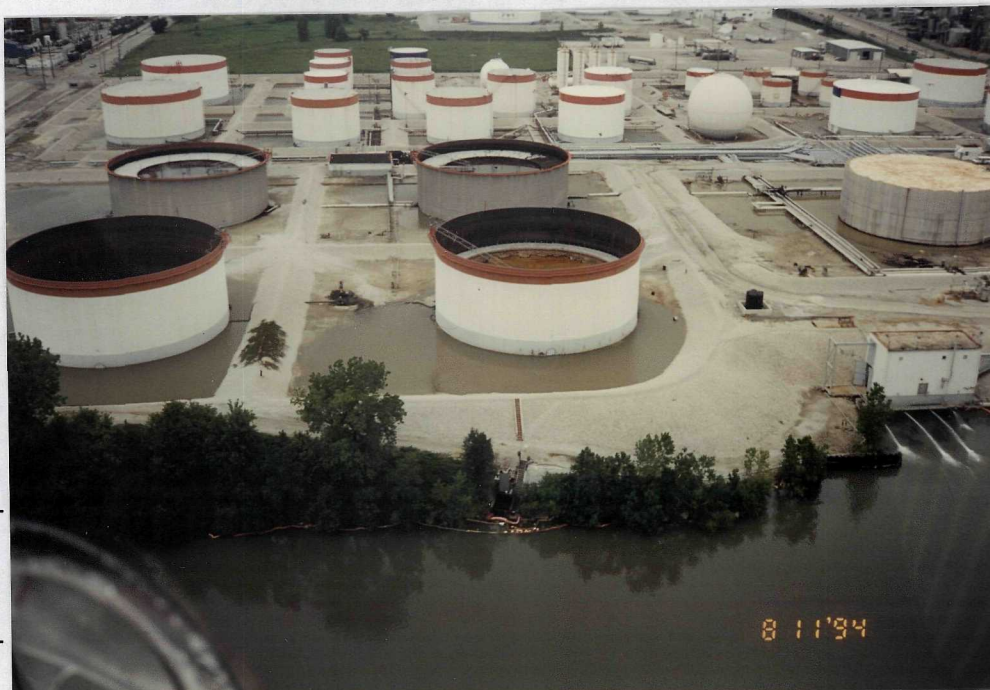
DESCRIPTION: Sorbent booms were placed surrounding the outfall  
originating on Clark's property.

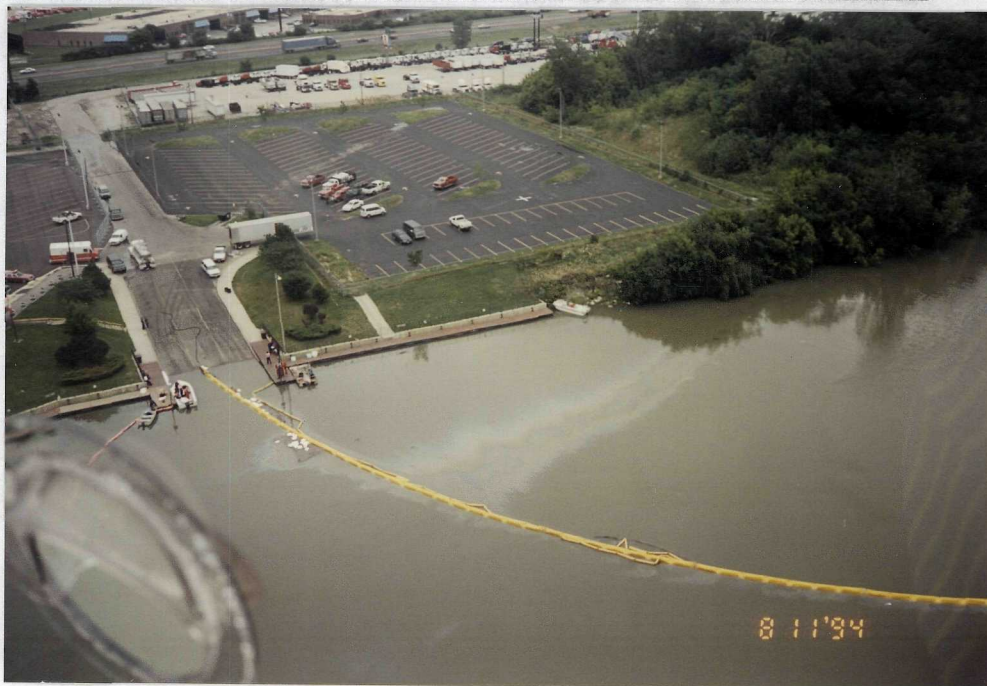
DESCRIPTION: View of the containment boom positioned by Clean  
Harbor at the boat launch.

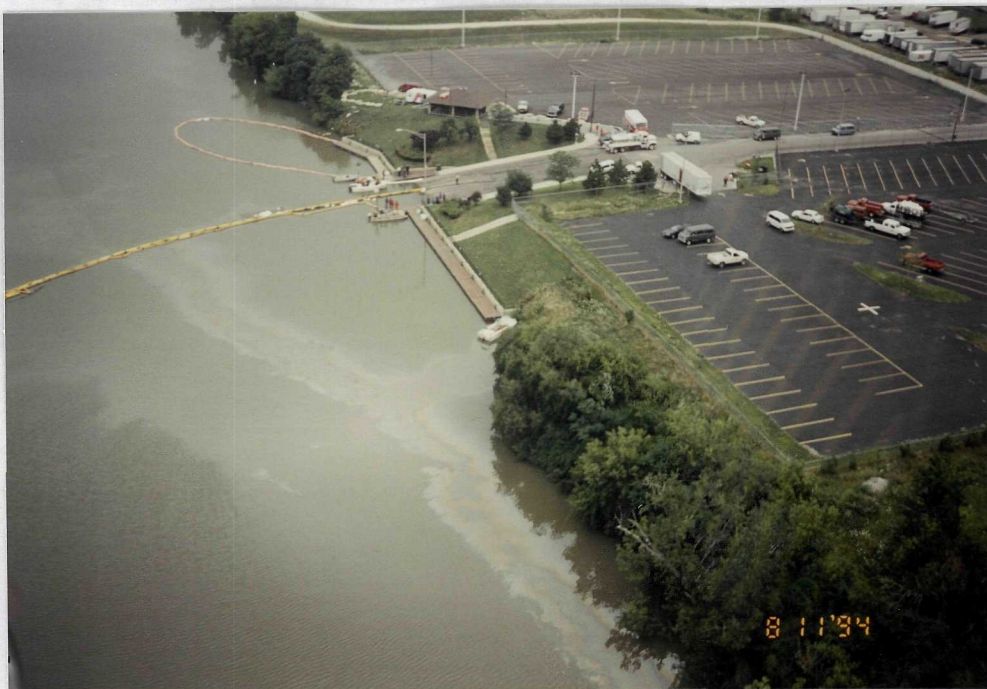
DESCRIPTION: Oil sheen flowing downstream on Calumet-Sag Channel.

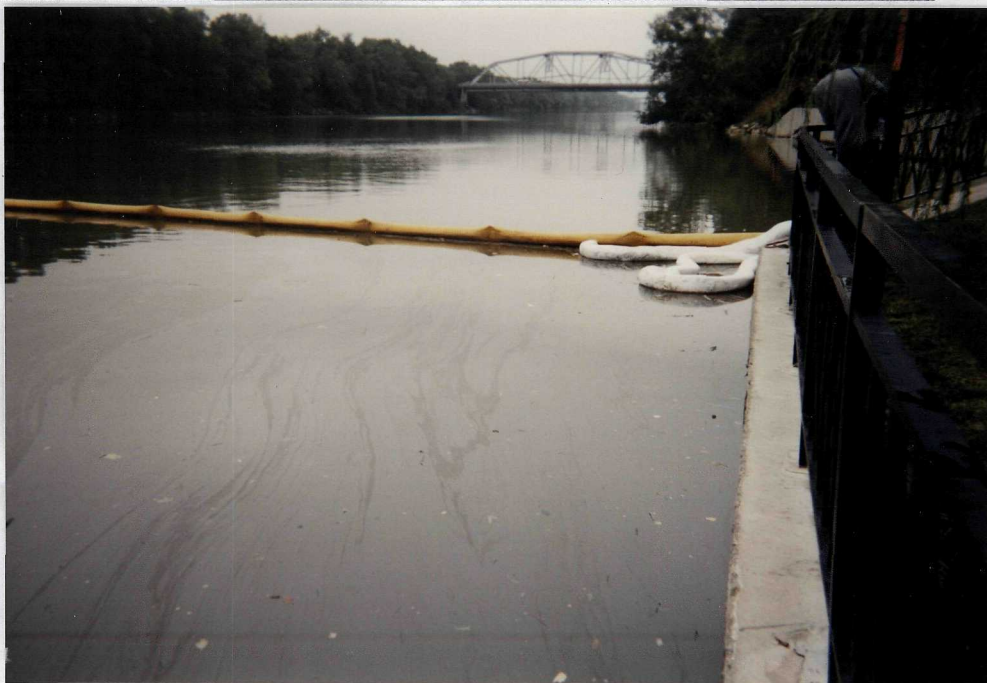
DESCRIPTION: Containment booms and sorbent booms positioned at the Metropolitan Water Treatment Plant intake, located downstream, at 127th Street and Harlem Avenue.

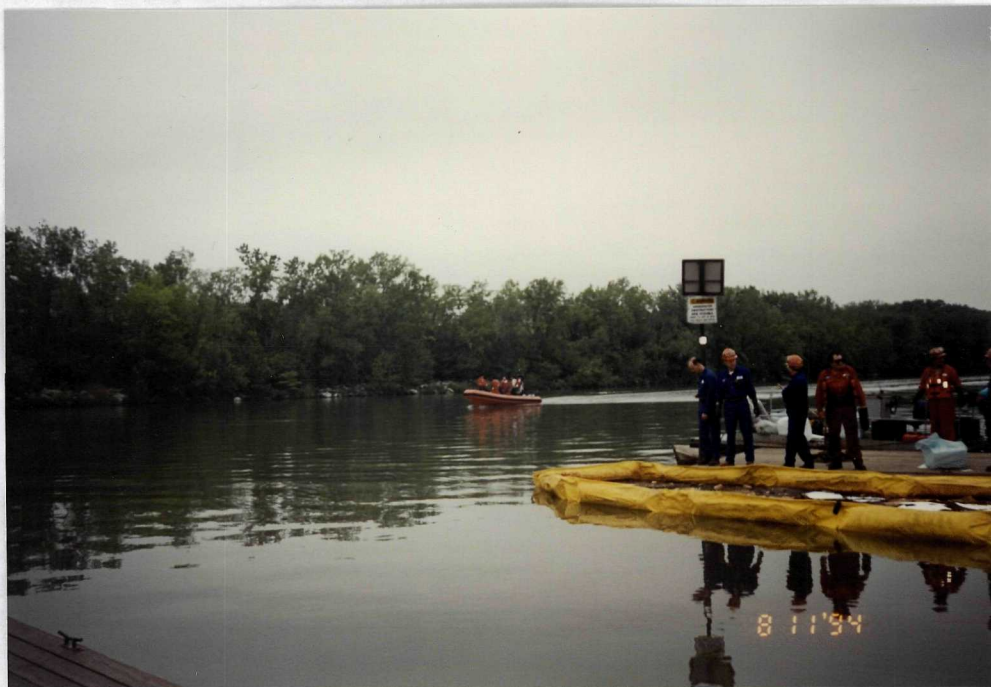
DESCRIPTION: Crew removed containment and absorbent booms from the  
channel. All booms were dragged by boat prior to removing them  
from the channel. Note: USCG tugboat in background.

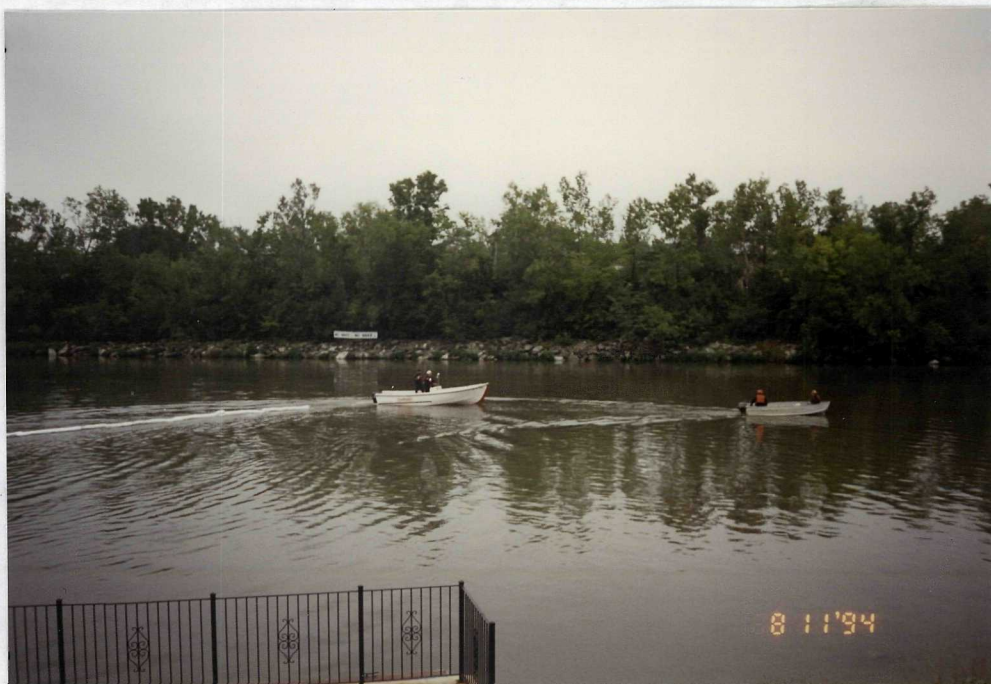
DESCRIPTION: The channel was inspected for the presence of any  
recoverable oil before the it was opened to traffic.

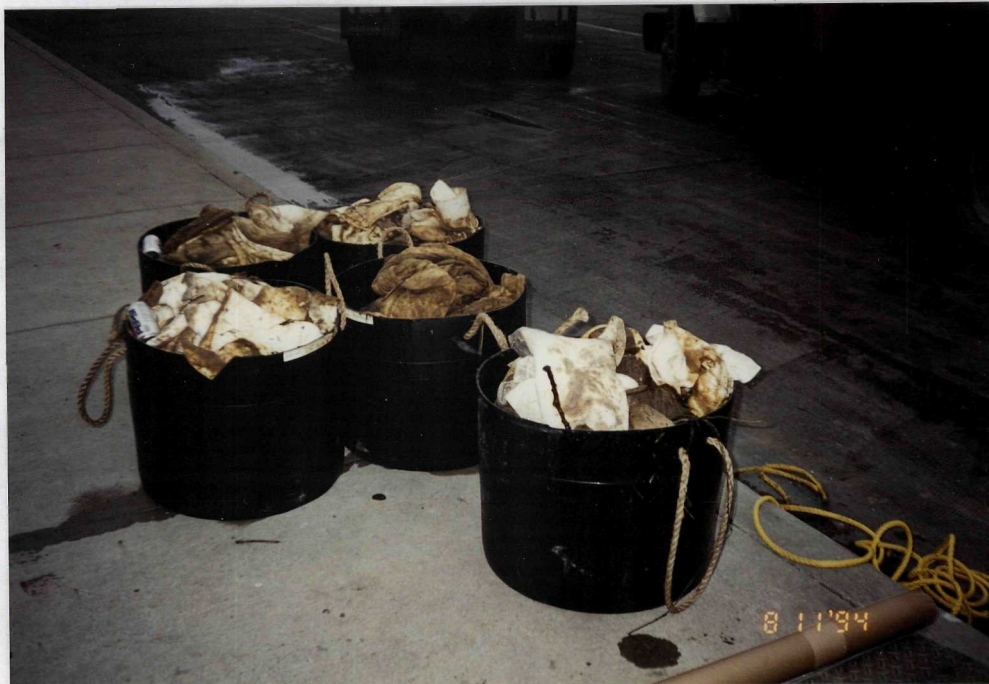
DESCRIPTION: Booms and pads utilized for oil recovery and  
containment awaiting disposal.

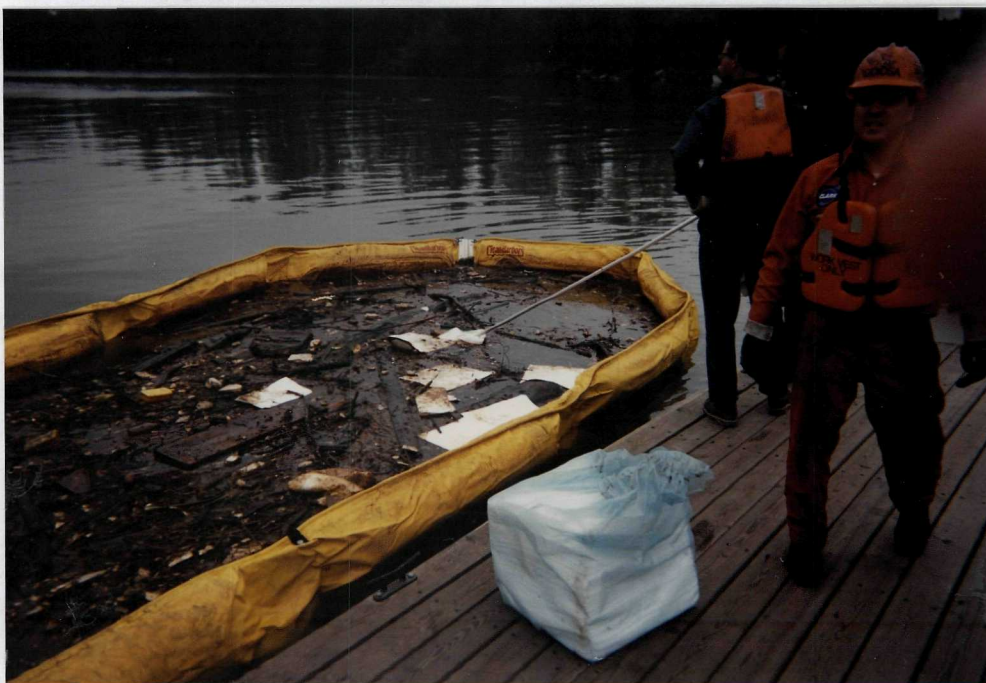
DESCRIPTION: Debris collected by dragging the booms across the  
water surface.

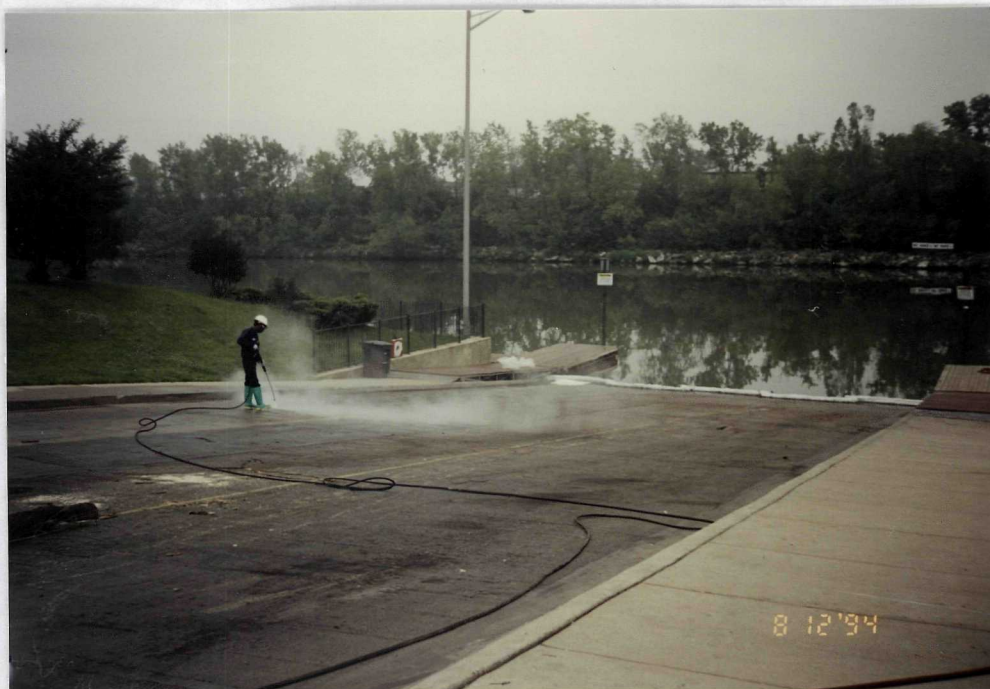
DESCRIPTION: Heritage Environmental decontaminated the boat ramp  
utilizing a pressure washer.
